Research Article

Assessment of water CT number, field uniformity and noise in diagnostics computed tomography scanners in Urmia metropolis, Iran

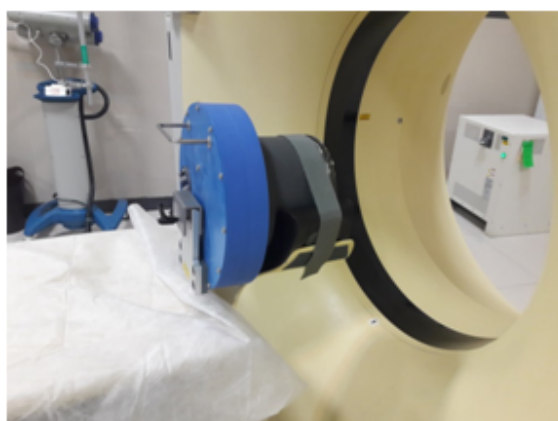
**Figure 1**. Phantom used in center A

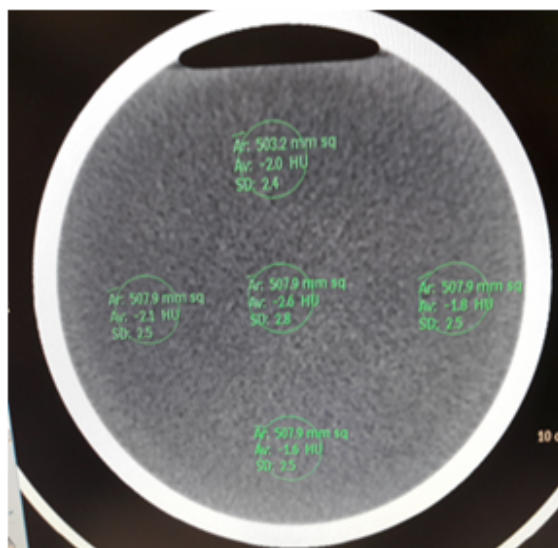
Figure 3. Field uniformity obtained from water phantomscan by Philips 64 slices scanner

Table2. Values for mean CT number for water andstandard deviation for 5 ROI in center A

Region of interest	1	2	3	4	5
Mean CT number	2.0	1.6	2.1	1.8	2.6
Standarddeviation	2.4	2.5	2.5	2.5	2.8

The CT numbers for water and field uniformity checked by the performed tests was the same as checking the reconstruction algorithm that computes CT numbers across the images. According to the standard instructions given by the manufacturers of CT machines, the CT number of water is equal to zero and the range of +/-3 in the center of an image and the range of +/-5 in the peripheral regions are acceptable.The standard for field uniformity is that the measured number in the center ROI should be less than 3 HU and for the 4 selected ROI in peripheral it should be in the range of +/- 5 HU acceptable in the center. The results of this study show that Philips 64 slices scanner in center A and Siemens 6 slices scanner have passed CT number for water and field uniformity tests because the values are within the acceptable limit.

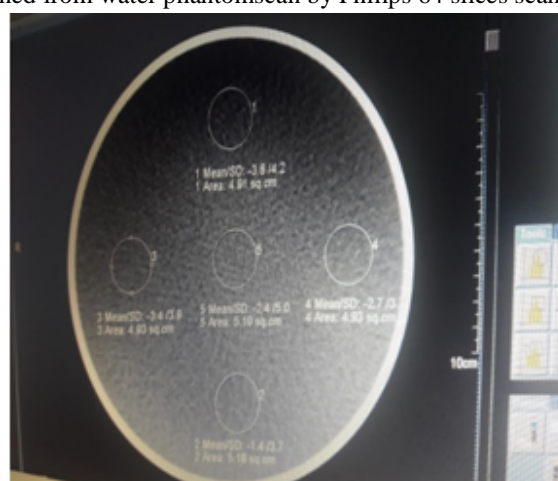
Figure 4. Field uniformity obtained from water phantom scan with Siemens 6 slices scanner

Table3. Values for mean CT number for water andstandard deviation for 5 ROI in center B

Region of interest	1	2	3	4	5
Mean CT number	3.8	1.4	3.4	2.7	2.4
Standarddeviation	4.2	3.7	3.9	3.7	5.0

This is a sign that the reconstruction algorithm that computes the CT number of the images is working correctly, therefore, good quality diagnostic images with low radiation dose are expected from the scanner.The noise level in CT images can be expressed as a percentage of image contrast in CT numbers. The standard deviation for noise should be +/-3. The maximum standard deviation between the center ROI and any peripheral ROI is less than +/-5 HU. The Philips 64 slices scanner passed noise test because the measured values are within the acceptable limit, But the Siemens 6 slices scanner don't pass noise test because the measured values are out of the acceptable limit andthis can compromise the quality of the images produced by the scanner which might lead to the wrong diagnosis.

CT scanners in Urmia have passed the CT number for water and field uniformity tests, but the Siemens 6 slices scanner doesn't pass the standard deviation test. One way should be to ensure that the images that produced by scanners have high quality and The patient's dose is within acceptable limits. Excessive noise can make the interpretation of images harder and may be confused, so it is recommended that a smooth reconstruction algorithm be used. Based on the study, the following recommendations are made:

1. Qualitative control tests should be carried out on a regular basis.

2. In case of observing the problem, inform the responsible.

3. Images of the QC tests should be kept in record.
