CASE REPORT**Intrapelvic Protrusion of a Broken Guide Wire Fragment during Fixation of a Femoral Neck Fracture**

*Research performed at the Department of Orthopedics, Urmia University of Medical Sciences, Urmia, Iran**Received: 11 May 2015**Accepted: 08 September 2015***Abstract**

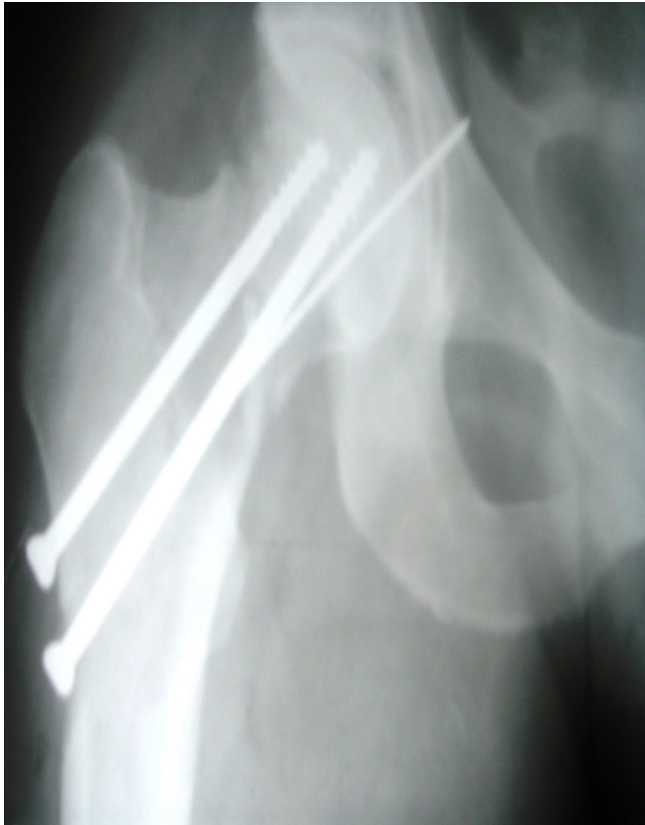
Figure 1. Internal oblique view of the right hemipelvis; X-ray shows the broken fragment of the guide wire that was passed through the hip joint and protruded into the pelvis.

Through the ilioinguinal extraperitoneal approach the inner surface of the acetabulum was touched and the protruding tip of the wire was recognized. The wire was retrieved from the pelvis under direct vision with pliers.

When the pictures of the image intensifier were reviewed, it was realized that the third pin somehow was deflected when it was inserted. This happened because of the flexibility of the wire and the hard quality of the bone. When the drilling on the third guide wire was advancing, the guide wire was cut because of a diverging angle and the distal fragment jammed in the cannulated drill bit. As the drill bit advanced further the jammed broken distal fragment of the guide-wire was pushed through the

acetabulum into the pelvis.
